# **TROUBLESHOOTING GUIDE**

**EXEDY**  
EXEDY Clutch Europe Ltd.

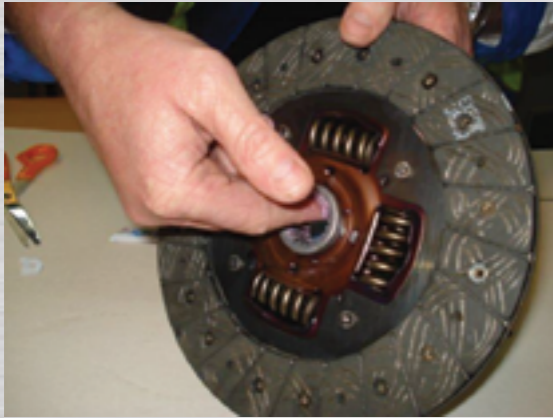
## Step 1

A tube of high melting point grease is supplied with every EXEDY clutch kit. Open the tube and apply a small amount of grease to the splined hub.

**\*Important, do NOT use the entire contents of the tube.**

Also lubricate the throw out fork to bearing contact area and pivot surface with the remainder of the grease.

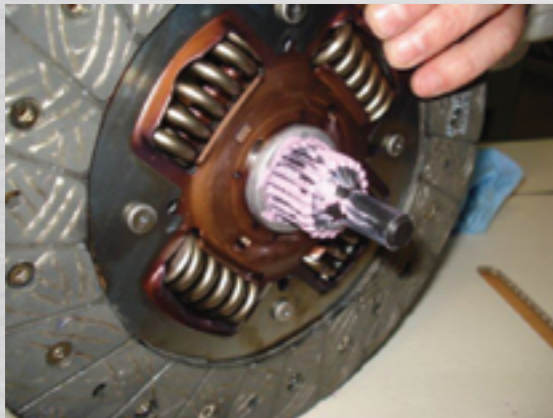
## Step 2

Slide the clutch disc onto the input shaft.

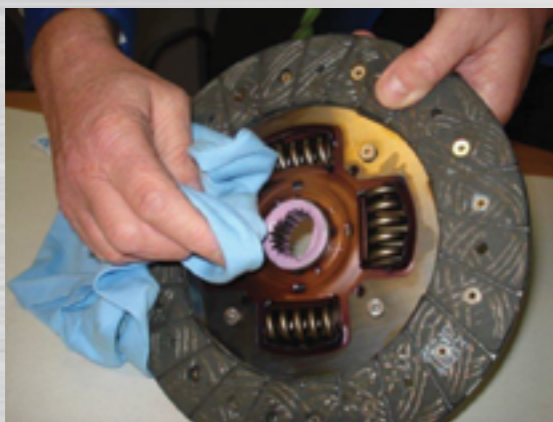
## Step 3

Remove any excess grease from the splined hub.

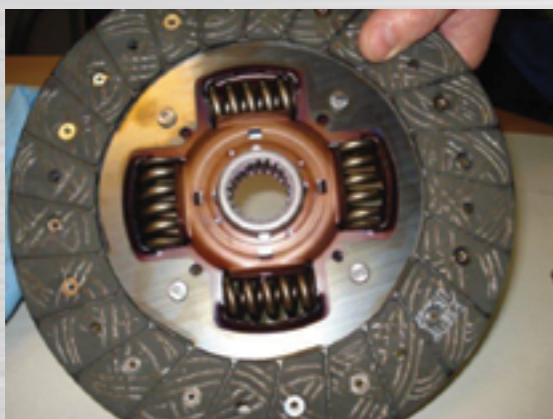
## Step 4

Do not contaminate the friction material as this will introduce the possibility of shudder and/or slip.

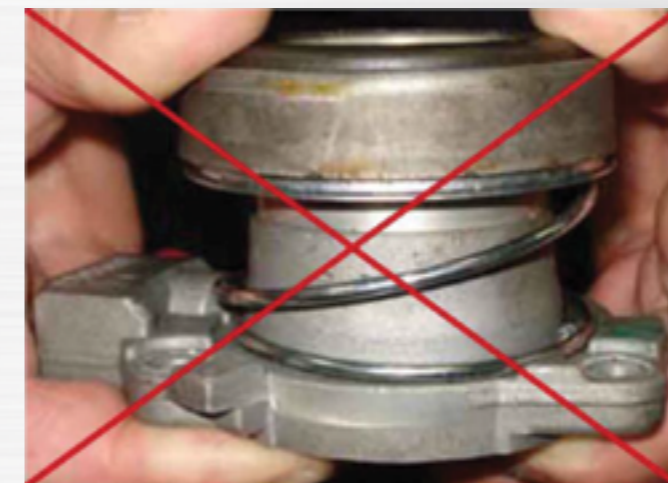
To prevent the possible premature failure of the CSC (Concentric Slave Cylinder), it is essential the technician follows some basic instructions while handling the CSC:

- Do not operate the cylinder by hand prior to installation. The cylinder does not contain any brake fluid (lubricant) at this stage and damage to the seal may occur. Similarly, the construction of the cylinder is comprised of two (2) major components. The cast body and an inner flanged tube that is pressed into the body. Should the cylinder be stroked prior to installation, the inner flanged tube can be forced out of position rendering the cylinder unserviceable.

**DO NOT COMPRESS**

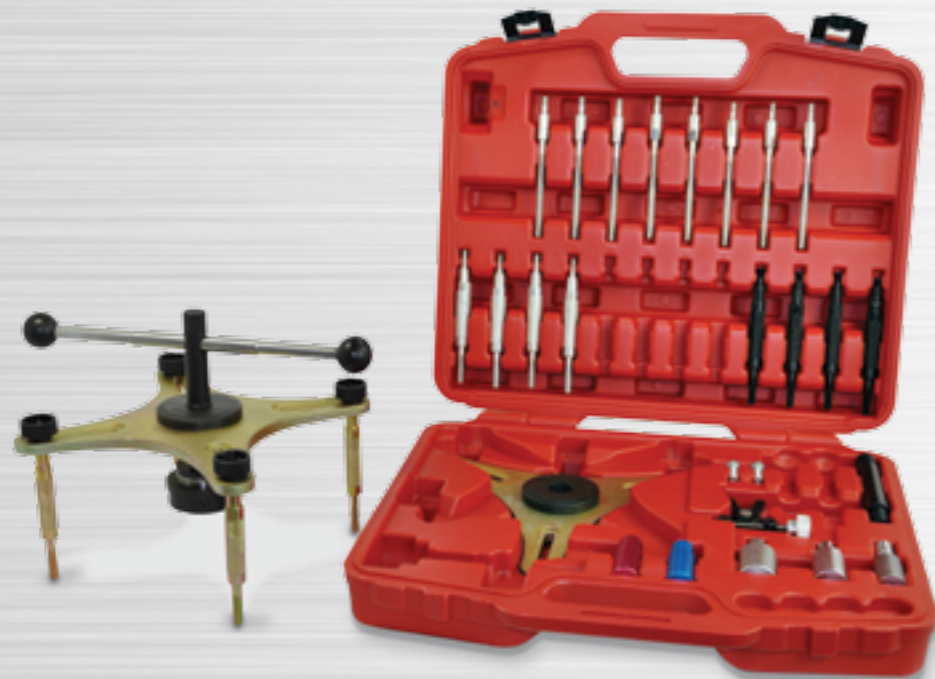
Self Adjusting Clutches can be found in many modern motor vehicles. Due to the intricate design and construction it is important that when fitting a Self Adjusting Clutch that the appropriate tools are used.

The SAC tool enables the professional removal and replacement of SAC-Clutches (Self-Adjusting-Clutch) in a smooth operation minimising the potential for damage to the cover assembly and/or self adjusting mechanism during the installation process.

The SAC Tool also ensures that the centre of the clutch disc is correctly aligned with the crankshaft; correct centring of the clutch disc also allows the input shaft to be positioned in the clutch disc hub smoothly minimising the risk of clutch disc or hub profile damage.

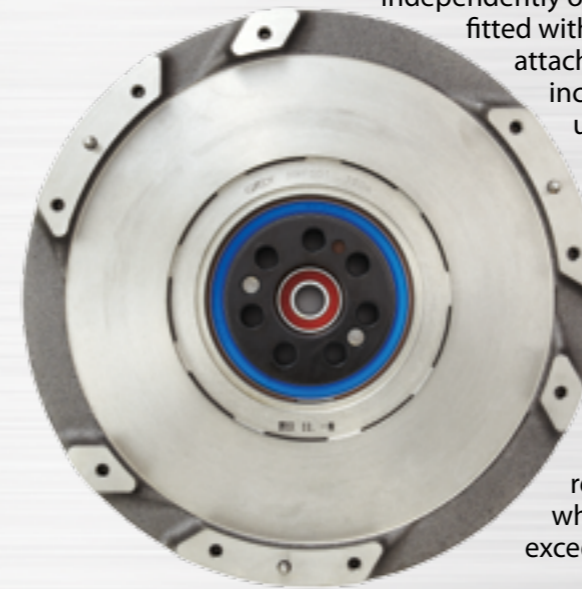
The Dual Mass Flywheel derives its name from the two main components (or masses) that operate independently of each other. The primary component (or mass) is fitted with a ring gear and sensor ring (if applicable) and is attached to the crank shaft. This primary component usually incorporates a dampening mechanism typically made up of torsion springs and friction washers that are ideally suited to absorbing torsional vibrations within the drivetrain. The clutch unit is then bolted onto the secondary component. Quite simply a DMF is a damper for your drivetrain.

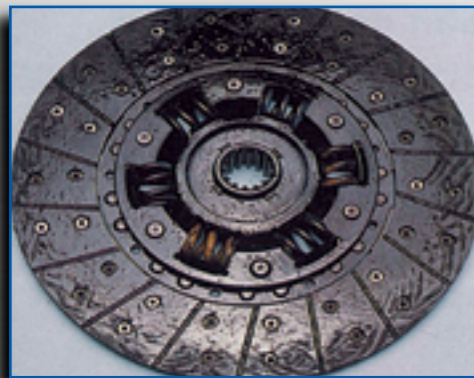
**PROBLEM:** Oily Facings  
**SYMPTOM:** Slipping clutch/Shuddering/Juddering clutch  
**CAUSE:** 1. Faulty main drive oil seal  
 2. Faulty rear main bearing oil seal  
**SOLUTION:** 1. Replace clutch disc  
 2. Replace faulty oil seals

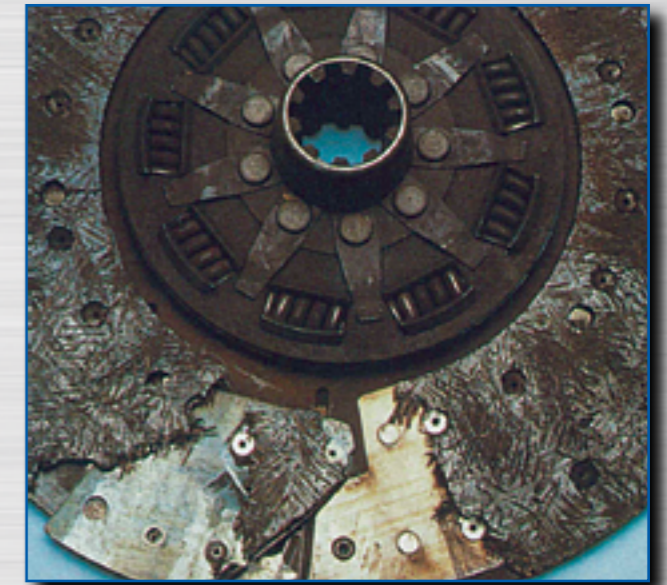
**PROBLEM:** Broken facing material on the clutch disc  
**SYMPTOM:** No drive/Noisy clutch  
**CAUSE:** Parts of the disc friction material are broken from the rivet along with part of the cushioned segment. This is due to down shifting of gear i.e. the speed of the vehicle at the rear wheels was travelling faster than the engine RPM, when gear was changed down  
**SOLUTION:** Driver education

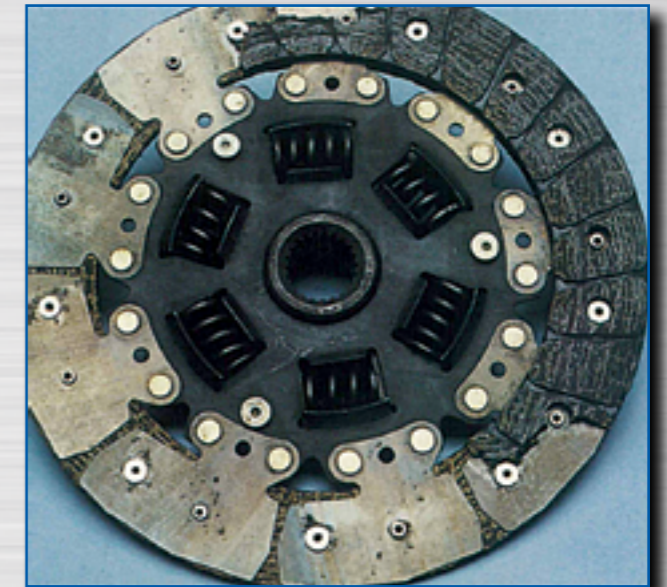
**PROBLEM::** Broken clutch facings flywheel side  
**SYMPTOM:** Clutch slips/Does not disengage  
**CAUSE:** 1. Overloading vehicle  
 2. Clutch disc has been replaced but not clutch pressure plate cover assembly  
 3. Lack of applied load (insufficient diaphragm spring pressure or coil spring pressure)  
**SOLUTION:** 1. Do not overload vehicle  
 2. Replace with complete clutch kit

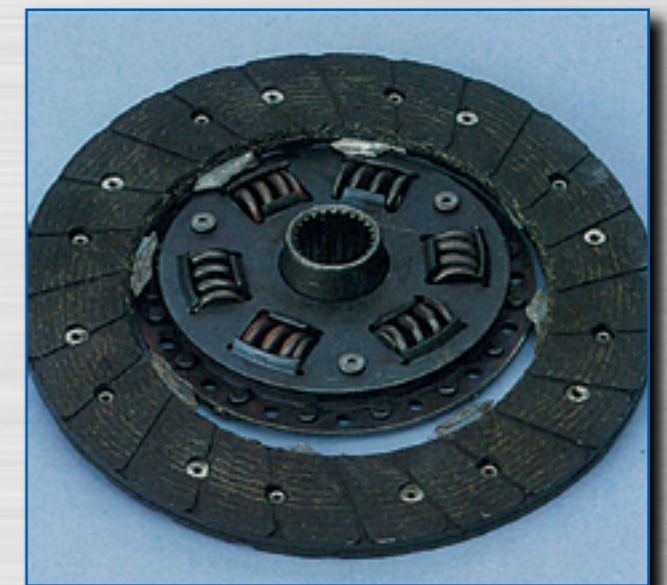
**PROBLEM:** Broken segments on clutch disc, sprung hub separated from facings  
**SYMPTOM:** Sudden clutch failure/No drive/Noisy clutch  
**CAUSE:** Cushion spring steel segments uniformly separated from hub area due to:  
 1. Faulty or worn pilot bearing or bushing  
 2. Hanging gearbox during installation  
 3. Dirt or chips between the mating surfaces of the engine bolt up areas.  
 4. Gearbox/transmission lock up. (i.e. Gear tooth jam)  
**SOLUTION:** 1. Check pilot bushing or bearing and replace if necessary. Align gearbox and use the assistance of a transmission jack and always clean mating surfaces before installation  
 2. Check gearbox for metal fragments then remove and repair as necessary

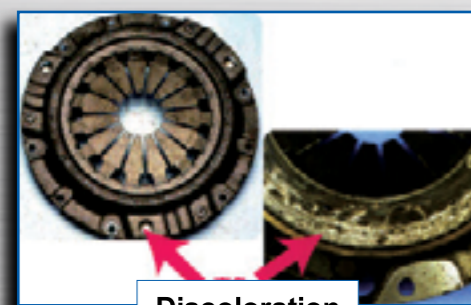
Friction surface, cover discoloration

**PROBLEM:** Discoloration on friction surface and/or clutch cover  
**SYMPTOM:** Slipping clutch  
**CAUSE:** 1. Driver abuse / improper driving technique  
 2. Incorrectly adjusted or faulty release mechanism extreme heat transfer due to prolonged clutch slipping has weakened the main spring of the clutch cover  
 3. Engine torque exceeds that of the clutch  
**SOLUTION:** 1. Driver education  
 2. Replace faulty parts and adjust to the manufacturer's specifications  
 3. Upgrade to an appropriate EXEDY sports clutch

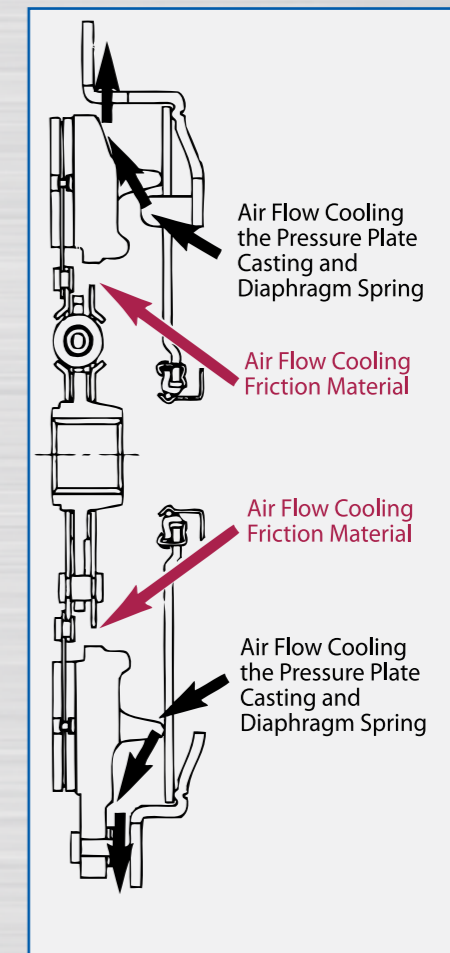
**PROBLEM:** Worn clutch disc facing fibres and dirt lodged between diaphragm spring and clutch cover housing, causing loss of clamp load

**CAUSE:** 1. Bell housing not degreased and cleaned. Careless installation of new clutch  
 The new clutch disc has not worn but the fibres that have become lodged in the new clutch cover are that of the previously worn clutch. It is a requirement due to ventilation designs that the bell housing area be free from old fibres, dirt and grease when installing a new clutch

2. This problem is common in 4 wheel drive vehicles when an inspection cover or a clutch fork cover boot has not been replaced when installing a new clutch

2. Ensure inspection locations and boots are replaced, tightened and well located

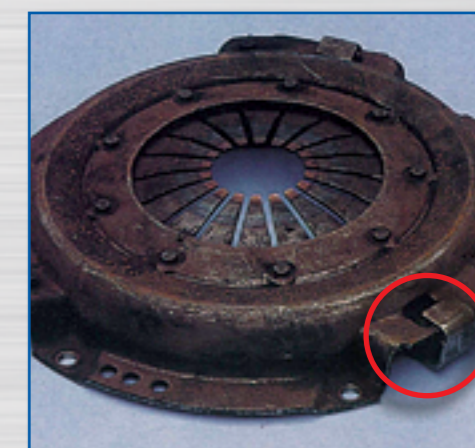
**PROBLEM:** 1. Installation assist clips not removed  
 2. Slipping clutch/excessive free travel  
 3. Unable to adjust  
 4. Will not transmit power

**CAUSE:** Clutch cover pressure plate assembly hold down clips (to assist ease of installation) have not been removed

**SOLUTION:** Remove clips after installation

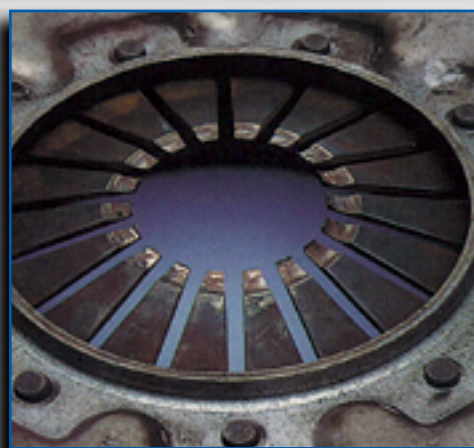
- PROBLEM:** Worn clutch disc facing fibers and dirt lodged between diaphragm spring and clutch cover housing
- SYMPTOM:** Difficult to disengage gear/ Slipping clutch
- CAUSE:**
1. Bell housing not degreased and cleaned
  2. Careless installation of new clutch
- SOLUTION:** Ensure the bell housing is thoroughly degreased and clean of dirt and fibers before installing a new clutch

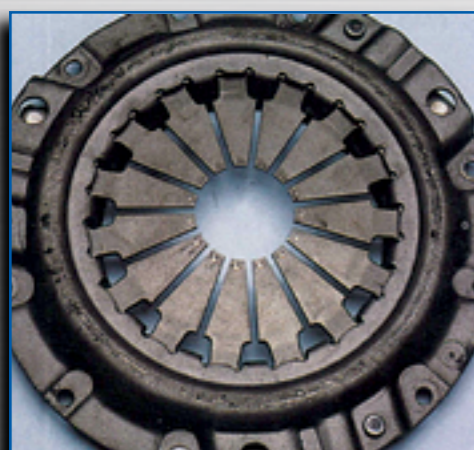
- PROBLEM:** Excessive wear on diaphragm tips and a highly glazed pressure plate casting
- SYMPTOM:** Slipping clutch/Shudder/Judder
- CAUSE:**
1. Lack of free travel/bearing riding on diaphragm
  2. Driver resting foot on the clutch pedal
  3. Nose cone worn/bearing stuck on a worn spot and not returning to original position
  4. Clutch slave cylinder corroded or worn and piston not returning to allow free travel
  5. Stretched or sticky cable
- SOLUTION:**
1. Adjust free play in clutch to the manufacturer's specification
  2. Driver education
  3. Replace gearbox main drive nose cone
  4. Replace clutch slave cylinder and check pressure build up in clutch master cylinder
  5. Replace cable. (Do not re-oil old cable)

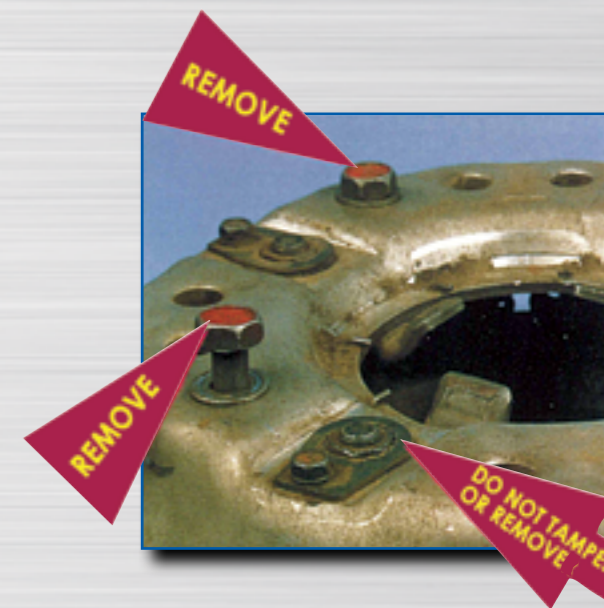
- PROBLEM:** No clamp load onto clutch disc
- SYMPTOM:** Slipping clutch
- CAUSE:**
1. Incorrect flywheel profile (no step or too much of a recess)
  2. Inferior remanufacture of old clutch cover
- SOLUTION:**
1. Always re-grind flywheel to the manufacturers specification
  2. Replace only with a new EXEDY pressure plate cover assembly

- PROBLEM:**
1. Hold down bolts still in pressure plate assembly
  2. Unable to adjust
  3. Will not transmit power
- SYMPTOM:** Clutch slipping just after installing new clutch
- CAUSE:** Clutch cover pressure plate assembly hold down bolts (to assist during installation) not removed
- SOLUTION:** Remove hold down bolts
1. Do not remove clutch lever adjustment nuts
  2. Common in Japanese trucks

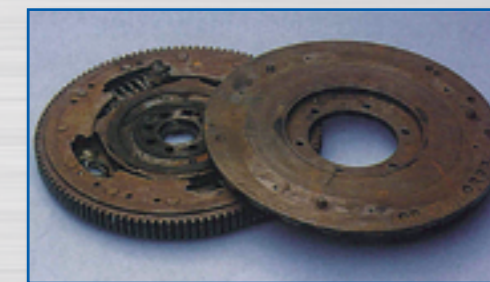
- PROBLEM:** Damaged clutch thrust bearing. Diaphragm spring excessively worn
- SYMPTOM:** Continuous clutch thrust bearing noise
- CAUSE:** The clutch has not been adjusted correctly since installation or the clutch has never been adjusted during any routine service. The clutch thrust bearing and the diaphragm of the clutch cover pressure plate assembly have worn indentations into each other
- SOLUTION:**
1. Fit new clutch kit as it is too late for adjustment of old clutch
  2. Always check free travel at service

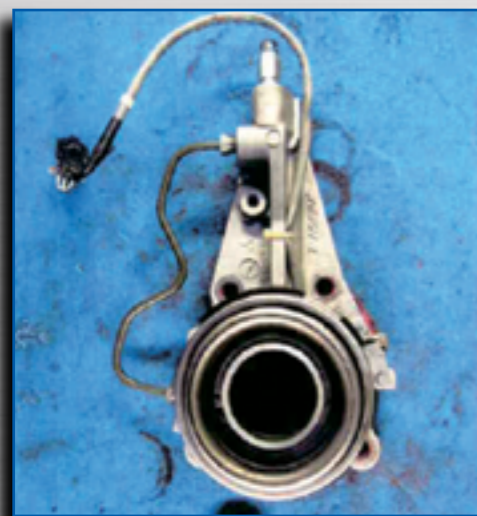
Malfunction of cylinder assembly

**PROBLEM:** Jammed, Leaking or completely destroyed Concentric Slave Cylinder (CSC)

**CAUSE:** **Slipping clutch:**  
Over stroking or excessive preload of the cylinder due to incorrect release mechanism adjustment or blockage in the hydraulic line limiting return fluid flow back to the master cylinder

- Air in system due to incorrect hydraulic bleeding procedure
- Fluid contamination resulted in premature failure of the cylinders internal piston seal
- Blockage in the hydraulic line has resulted in complete cylinder failure
- Mounting surface on front of transmission not cleaned prior to fitment of cylinder, preventing o-ring seal properly

- Always flush the hydraulic system and only use new hydraulic fluid when fitting a new cylinder. Adjust release mechanism to the manufacturer's specifications. Replace faulty hydraulic components (master cylinder, dampening valves, hydraulic lines etc)
  - Adjust release mechanism to the manufacturer's specifications
  - Always flush the hydraulic system and only use new hydraulic fluid when fitting a new cylinder
  - Replace faulty hydraulic components (master cylinder, dampening valves, hydraulic lines etc).
  - Always ensure the mounting surface is clean and the o-ring seal (where required) is used to provide a positive seal

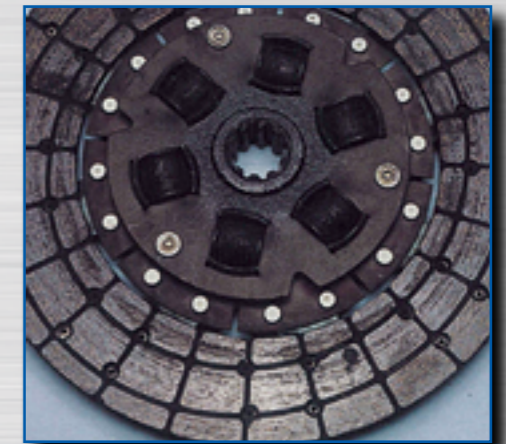
**PROBLEM:** Melted grease on clutch disc side plate  
**SYMPTOM:** Clutch shudders/Judders and/or slips  
**CAUSE:** 1. Excessive grease on transmission input shaft.  
 2. Melted grease on the friction material will affect friction coefficient of disc facing  
**SOLUTION:** 1. Lightly grease spline, wiping of excessive grease and ensure there is smooth sliding of clutch disc on main drive  
 2. Replace clutch disc with new disc unit  
 3. Use only high melting point grease

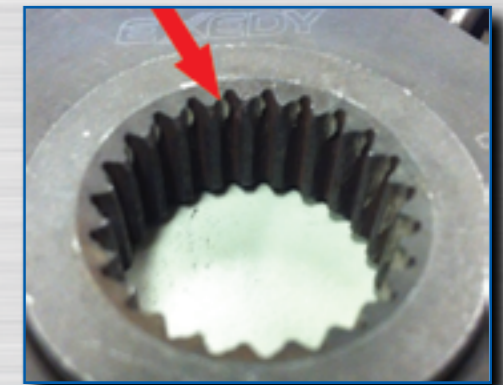
- PROBLEM:** Damaged torsion springs
- SYMPTOM:** Unable to disengage gears/Noisy clutch
- CAUSE**
1. When engine torque is higher than clutch torque, this misapplication causes springs to deteriorate
  2. Misalignment between engine crank shaft and transmission main drive shaft causes this problem during installation of transmission
- SOLUTION:**
1. Choose and fit the appropriate EXEDY clutch to suit the application
  2. Replace deteriorated pilot bearing, bush, missing or damaged dowels and remove any contamination or burrs from mating surfaces between the engine and transmission

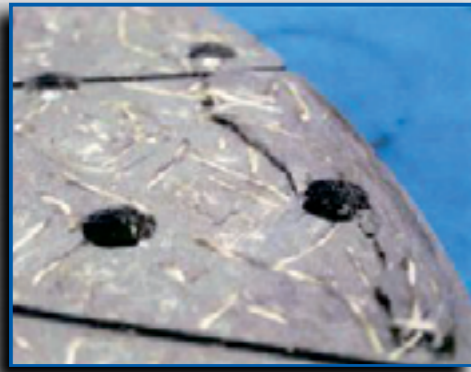
- PROBLEM:** Damaged facing material
- SYMPTOM:** Difficult to disengage gears
- CAUSE:** Clutch disc has been dropped possibly during installation or damaged in transit
- SOLUTION:** 1. Inspect parts prior to installation  
2. Handle parts carefully

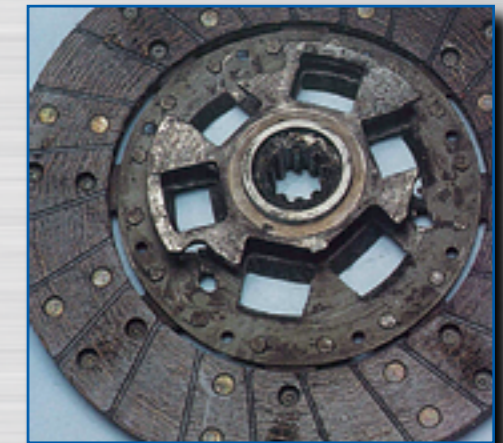
- PROBLEM:** Broken rubber dampeners
- SYMPTOM:** Noisy/No disengagement (rubber torque stopper type clutch disc)
- CAUSE:** 1. Use of inferior or imitation clutch disc  
2. Clutch wound past torque capacity  
3. Inferior rubber compound
- SOLUTION:** 1. Fit genuine EXEDY clutch  
2. Driver education

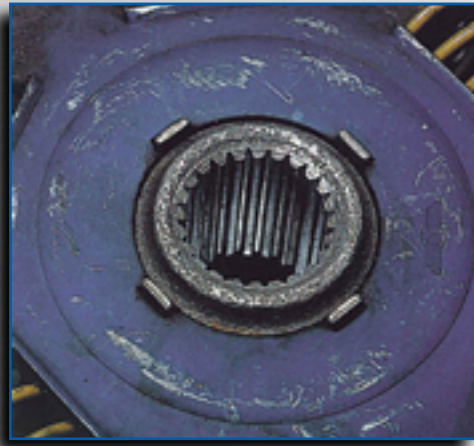
**PROBLEM:** Damaged or burred splines on the clutch disc  
**SYMPTOM:** Unable to re-install transmission after fitting replacement clutch  
**CAUSE:** Careless fitting practice, clutch disc not checked on the transmission input shaft prior to installation, different number of splines on the clutch disc compared to that on the transmission input shaft  
**SOLUTION:** 1. Always refer to EXEDY packaging instructions before installing clutch  
 2. Try clutch disc on main drive for smooth sliding before installation

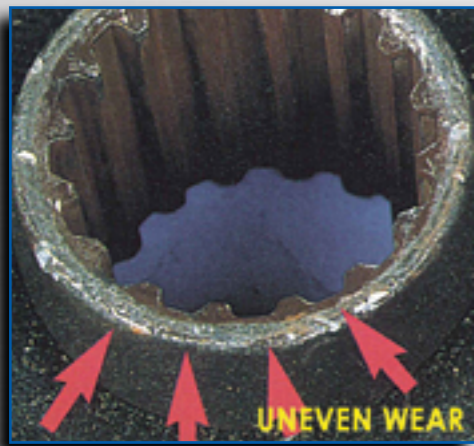
**PROBLEM:** Damaged or burred splines on clutch disc  
**SYMPTOM:** Difficult to disengage gears  
**CAUSE:** Defective pilot bearing or bush. This causes angular wear on the spline teeth, not allowing the clutch disc to slide on the spline teeth. It also causes the clutch disc to possibly stick on to the flywheel or not separate from the clutch cover pressure plate assembly. This results in poor separation or no disengagement  
**SOLUTION:** Fit new pilot bearing or bush

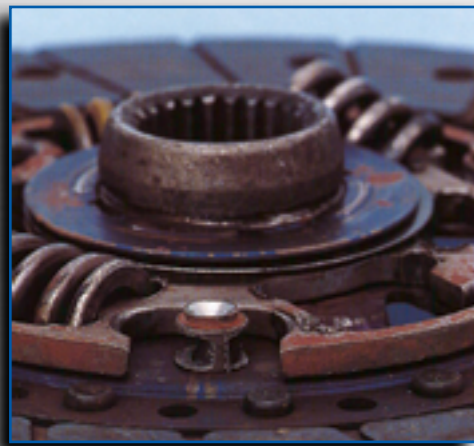
**PROBLEM:** Torsion dampener stopper springs thrown out of side plate/stop pins worn  
**SYMPTOM:** Noisy clutch/unable to engage or disengage gear  
**CAUSE:** 1. Improper driving practice i.e. "dropping" the clutch whilst engine is turning at extremely high revolutions  
 2. Down changing of gears i.e. 5th gear to 2nd gear by low speed/high driving gear method  
 3. Wear on the stop pins indicates the clutch plate has been wound past specified torque loading. This has the same affect on the springs  
 4. Misalignment

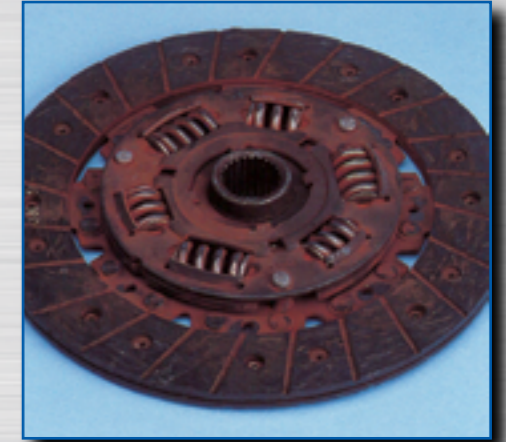
**PROBLEM:** Torque stopper springs broken  
**SYMPTOM:** Noisy clutch with vibration  
**CAUSE:** 1. Misalignment between engine crank-shaft centre and gearbox main drive  
 2. If the torsion springs are damaged along with the torque stopper pin then it is evident that the clutch has been wound past its torque capacity  
**SOLUTION:** 1. Refer misalignment tips on page 56  
 2. Driver education

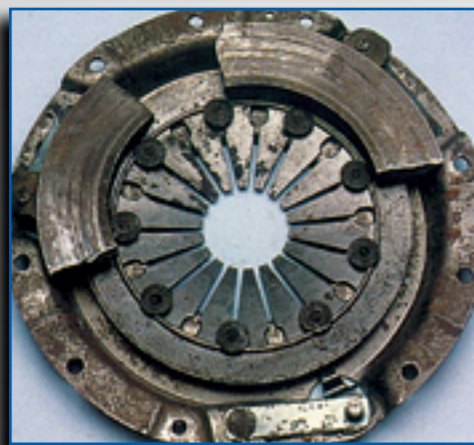
**PROBLEM:** Burst pressure plate casting  
**SYMPTOM:** No disengagement.  
**CAUSE:** 1. Over revving of engine that has exceeded vehicle manufacturer's specifications  
 2. Over heating of casting due to constant abuse of clutch. The main spring has weakened through extreme influence of heat

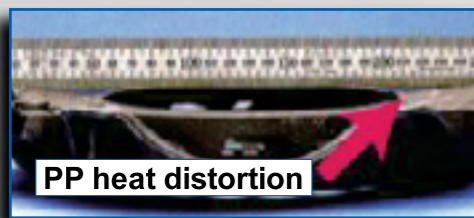
PP heat distortion

Pressure plate heat distortion

**SOLUTION:** 1. Driver education  
 2. Do not use EXEDY covers where engine has been modified to exceed manufacturer's RPM specifications  
 3. Use EXEDY specified sports clutch. Refer to EXEDY standard range or EXEDY Sports listings where covers are manufactured with nodular iron castings

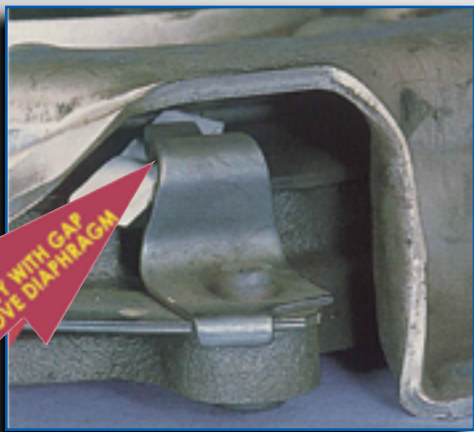
**PROBLEM:** Stretched/damaged retractor clip above the diaphragm

**SYMPTOM:** Difficult engagement/disengagement after installation of new clutch

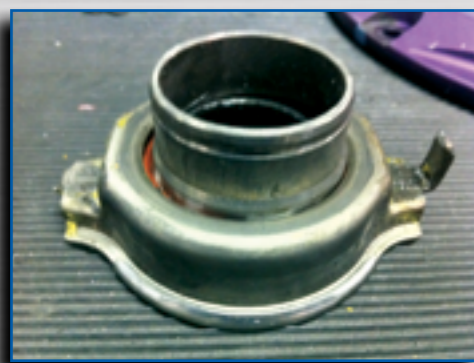
- PROBLEM:** Broken ears on pull type release bearing (Subaru)
- SYMPTOM:** Difficulty engaging or disengaging gears
- CAUSE:** Interference from wiring loom during installation can apply undue force to clutch fork and release bearing, resulting in breakage of bearing ears
- SOLUTION:** Use caution when re-installing transmission to avoid interference from the wiring loom

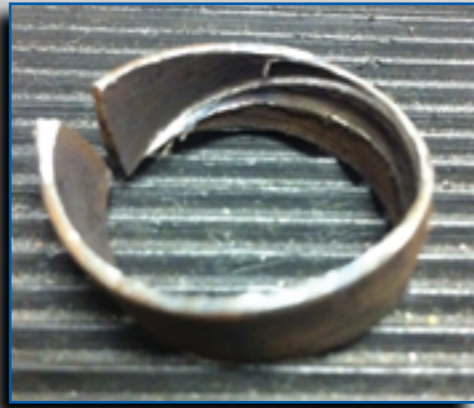
**PROBLEM:** Damaged pilot bushing

**SYMPTOM:** Difficulty engaging or disengaging gears. Noisy clutch

**SOLUTION:**

1. Align the transmission to the crank/engine block during installation. Never force transmission to the engine
2. Do not use bell housing bolts to force the transmission onto the engine block
3. Proper installation practices

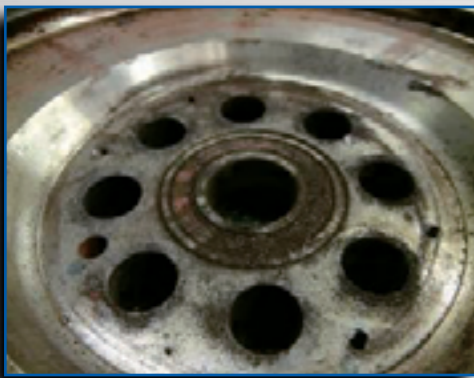
Deteriorated pilot bearing

**PROBLEM:** Notchy pilot bearing

**Difficult to disengage gear:** Reuse of bearing which is not smooth movement causes difficult to disengage gear, because it transmits torque under disengagement condition

**SOLUTION:** Always replace with new pilot bearing when you replace the clutch

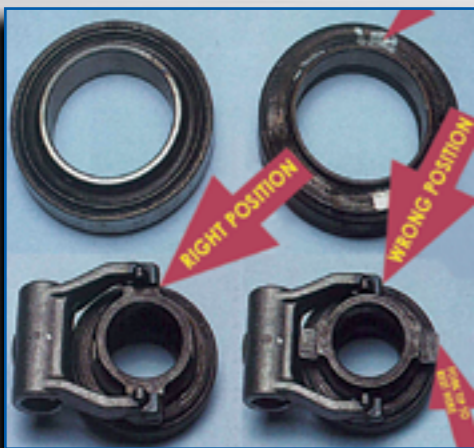
**PROBLEM:** Excessive score marks on clutch thrust bearing

**SYMPTOM:** Excessive free travel/clutch does not disengage/ noisy - Japanese range of trucks

**SOLUTION:**

1. Check tension on wire retaining clip
2. Always check the bearing on the clutch release fork after installation. Move the fork in both directions to ensure the bearing is secure before re-fitting the gearbox

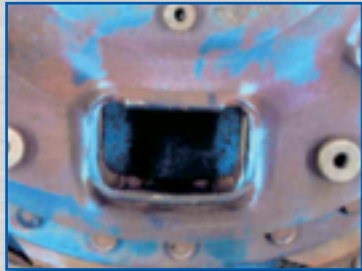
**PROBLEM:** Broken facings  
**SYMPTOM:** Slipping clutch/Shudder/Judder/Noisy clutch. Unable to drive  
**CAUSE:** Following factors lead to high temperature of friction surface, resulting in this problem  
 1. Driving with a foot on the clutch pedal  
 2. Overloading vehicle  
 3. Improper starting gear  
 4. Clutch pedal height or free play maladjustment  
 5. Oil/grease contamination  
**SOLUTION:** 1.~ 3. Driver education  
 4. Adjust pedal free play according to the service manual

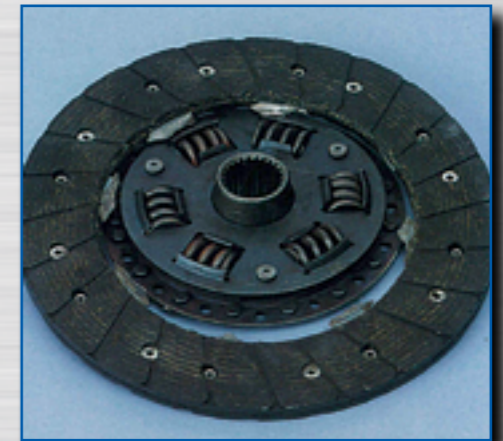
**PROBLEM:** Broken facing of clutch disc on clutch cover assembly, pressure plate side  
**SYMPTOM:** Noisy clutch/Slipping clutch  
**CAUSE:**  
 1. Improper driving practice; down changing gear constantly  
 2. The speed of the vehicle is actually higher than of the shifted to gear  
 3. The gearbox and drivetrain revolutions are turning faster than the speed of the engine at the time: sudden clamp damaged the facings  
 4. Excessive grease on the transmission input shaft  
**SOLUTION:** 1. Driver education  
 2. Proper fitting practice

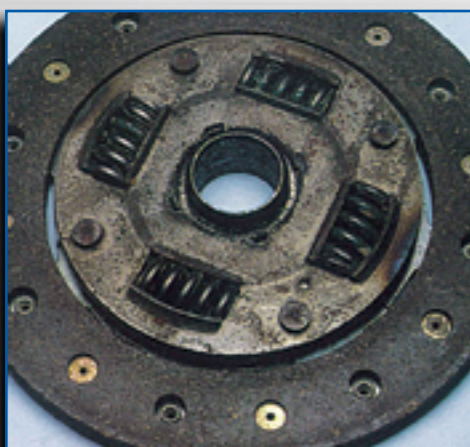
**PROBLEM:** Splines completely disintegrated on the clutch disc  
**SYMPTOM:** No drive/Noisy clutch  
**CAUSE:** 1. Clutch disc not tested on spline before installation  
 2. Missing spigot/pilot bearing or bushing  
**SOLUTION:** 1. Always check the number of splines on the clutch disc match those on the transmission input shaft and that the disc slides smoothly onto the input shaft prior to installation  
 2. Check and replace spigot/pilot bearing of bushing. (Mini UK and Europe: Check primary gear for worn bushing; if worn replace)

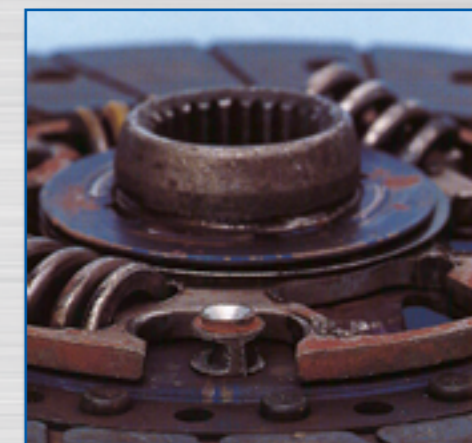
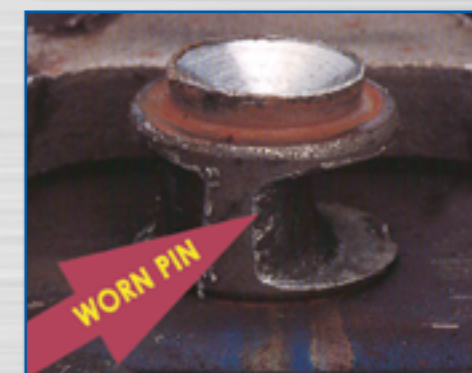
**PROBLEM:** Excessive wear on diaphragm tips

**SYMPTOM:** Difficult to disengage gear/ Noisy clutch

**CAUSE:** Driveline misalignment. Wear to both the diaphragm levers and inside fulcrum of the clutch cover result in less pressure plate lift and difficulty in engaging gears

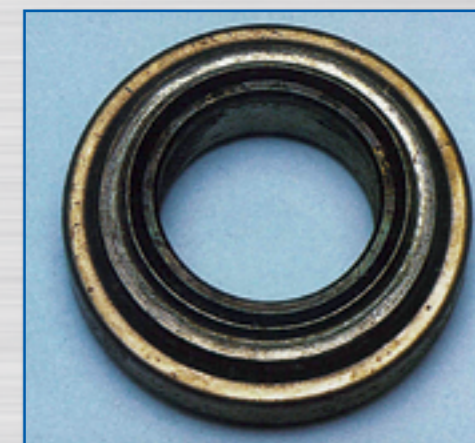
**PROBLEM:** Damaged clutch/thrust release bearing

**CAUSE:** Bearing fitted incorrectly

**SOLUTION:** Fit new clutch thrust bearing the right way around

*Note: Ensure cover pressure plate assembly diaphragm has not been damaged from previous clutch thrust bearing*

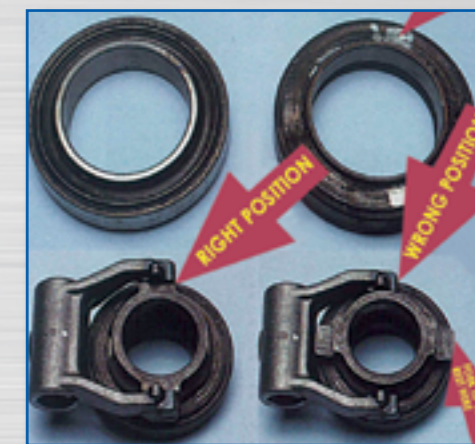
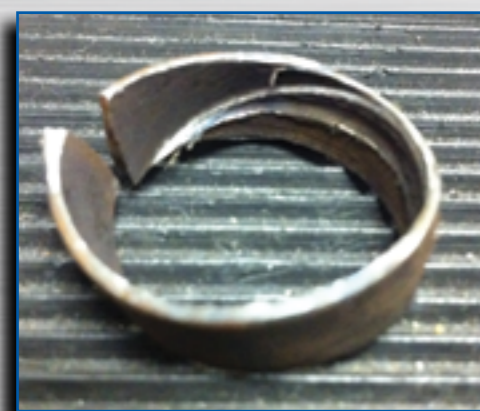
**PROBLEM:** Damaged pilot bushing

**SYMPTOM:** Difficulty engaging or disengaging gears/Noisy clutch

**CAUSE:** Improper installation practices. Forcing the input shaft/transmission on crank bushing engine block

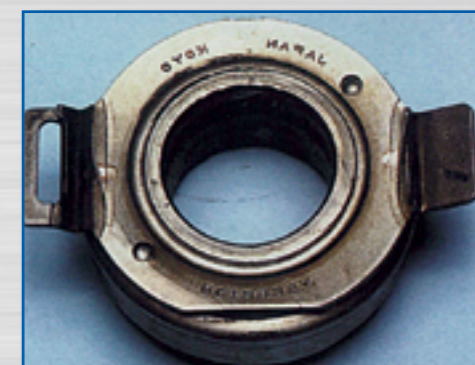
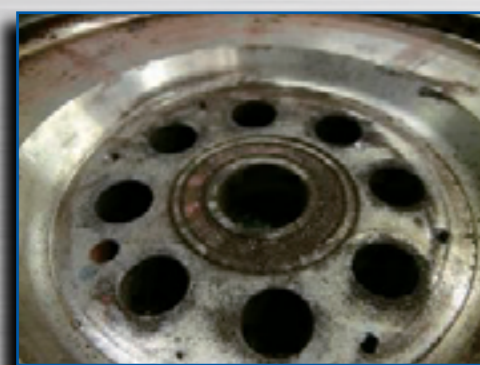
Deteriorated pilot bearing

**PROBLEM:** Notchy pilot bearing

**CAUSE:** Reuse of pilot bearing

Reuse of deteriorated pilot bearing may cause abnormal noise from the bearing under depressing clutch pedal condition

Reuse of bearing which is not smooth movement causes difficult to disengage gear, because it transmits torque under disengagement condition

**SOLUTION:** Always replace with a new pilot bearing when you replace the clutch

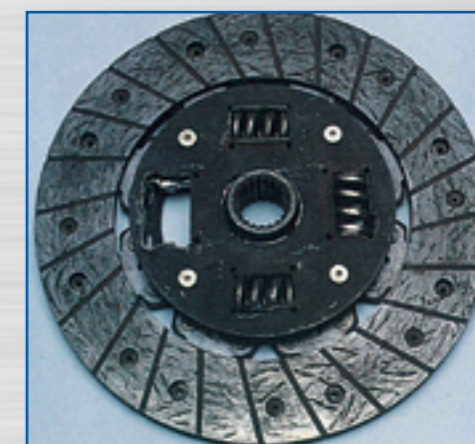
**PROBLEM:** Torque stopper springs broken

**CAUSE:** 1. Misalignment between engine crank-shaft centre and gearbox main shaft  
2. If the torsion springs are damaged along with the torque stopper pin then it is evident that the clutch has been wound past its torque capacity

**SOLUTION:** 1. Refer misalignment tips on page 56  
2. Driver education

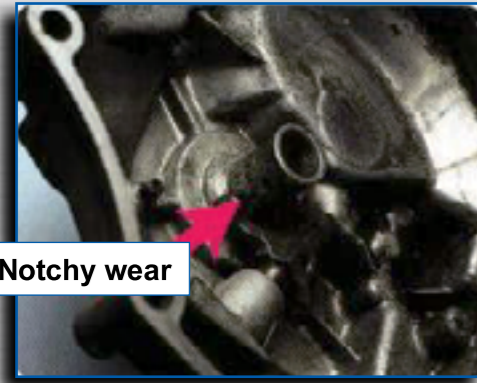
Notchy wear on front cover

**PROBLEM:** Abnormal wear on the release bearing guide tube  
**SYMPTOM:** Sticky or notchy pedal/Slipping clutch  
**CAUSE:** Driveline misalignment. No grease applied to guide tube  
**SOLUTION:** Refer misalignment tips on page 56. Apply appropriate grease. Renew worn parts

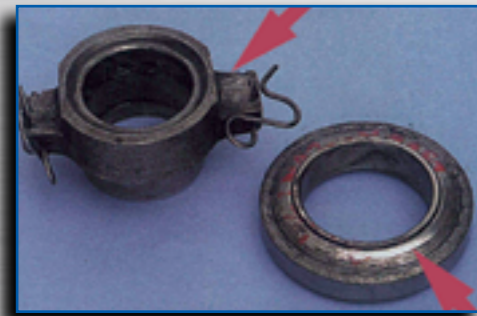
**PROBLEM:** Worn clutch thrust bearing carrier  
**SYMPTOM:** Pulsating pedal with engine running  
**CAUSE:** Faulty installation as the clutch thrust bearing carrier is worn on the saddle where the fork pivots. This also reduces the tension on the wear clip retainer. In this case, due to the lack of tension, the fork has become dislodged and scored the back of the bearing  
**SOLUTION:** Always replace worn clutch thrust bearings, carriers and worn forks

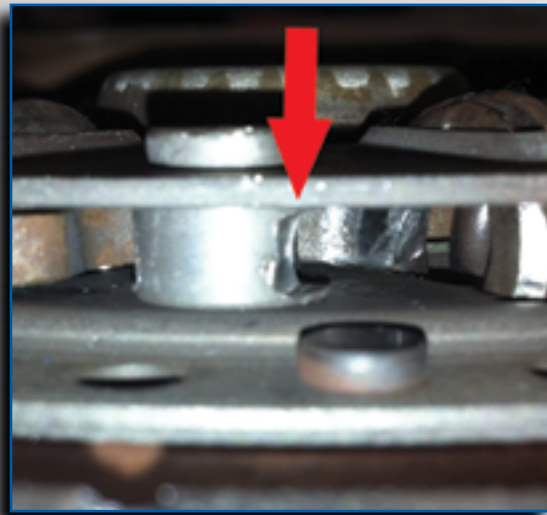
**PROBLEM:** Noise/Difficulty engaging gears  
**CAUSE:** Broken drive hub on clutch disc. Damaged stop pin from high RPM clutch "dumping" or "side skipping" from a stop  
**SOLUTION:** Driver education, change driving style

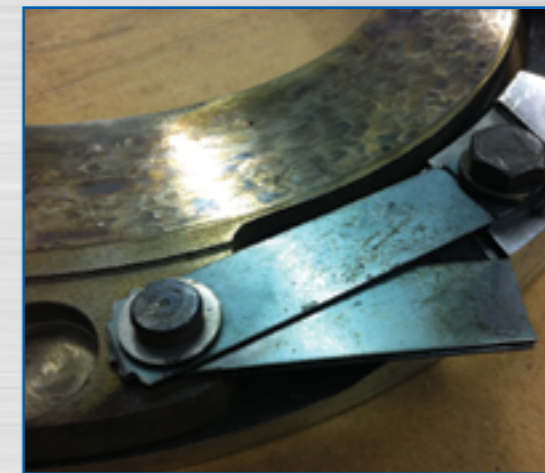
**PROBLEM:** Chipped facing  
**CAUSE:** Improper break in of clutch assembly  
**SOLUTION:** Follow manufacturer's break in procedures

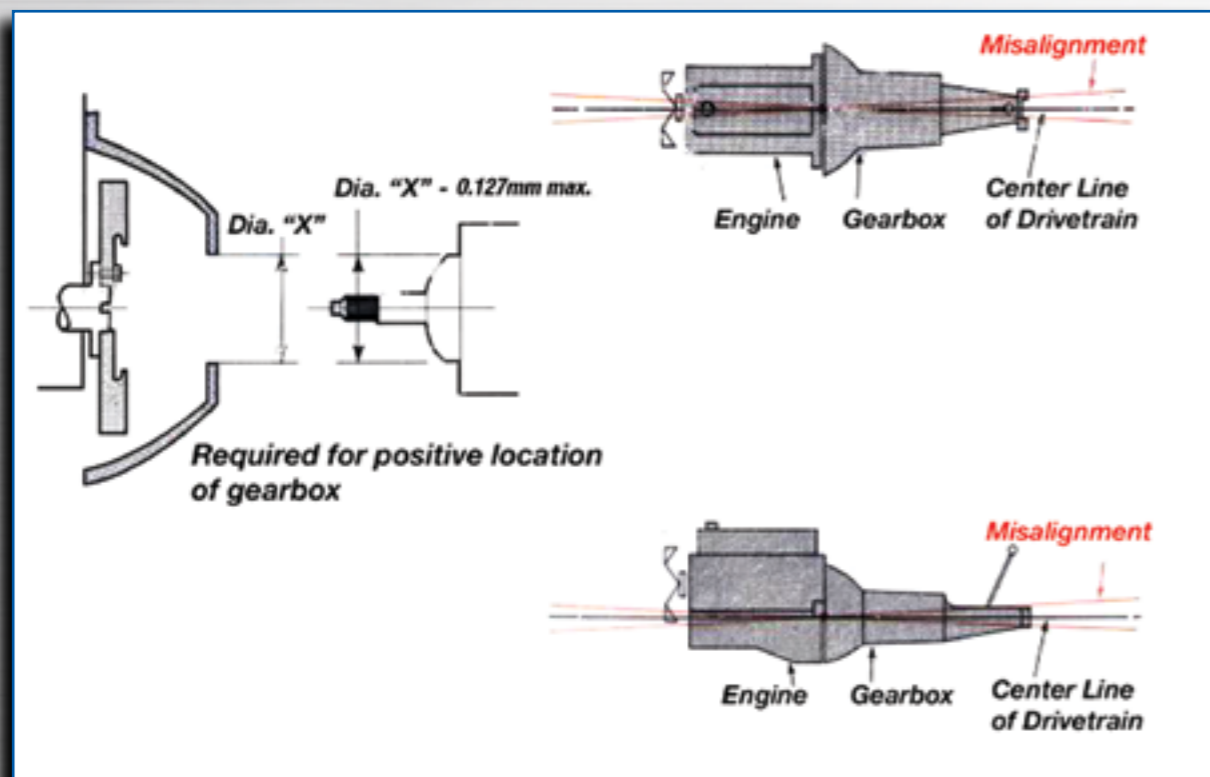
## Driveline Misalignment in General/Tips

1. Warped alloy bell housing
2. Tubular dowel pin guides crushed during fitting of bell housing to mating dowel pin hole and/or missing dowel pins.
3. Worn gearbox quill/gearbox main drive nose cone bearing slide: causing bearing to come in contact with the diaphragm of cover assembly off centre line whilst actuating clutch.
4. Dirt-chips-wiring harness clips-hydraulic pipe clamp clips – thick grease build up interfering between the mating surface of the gearbox bell housing and motor.
5. Worn Spigot bushes and pilot bearings along with front gearbox main bearings to be checked for wear.
6. Exchange engines and gearboxes have missing dowel pins. Ensure you remove pins from your product when you send your core for remanufacture and refit when installing the new clutch.
